NBS BUILDING SCIENCE SERIES 120

Guidelines for Stair Safety

Issued May 1979

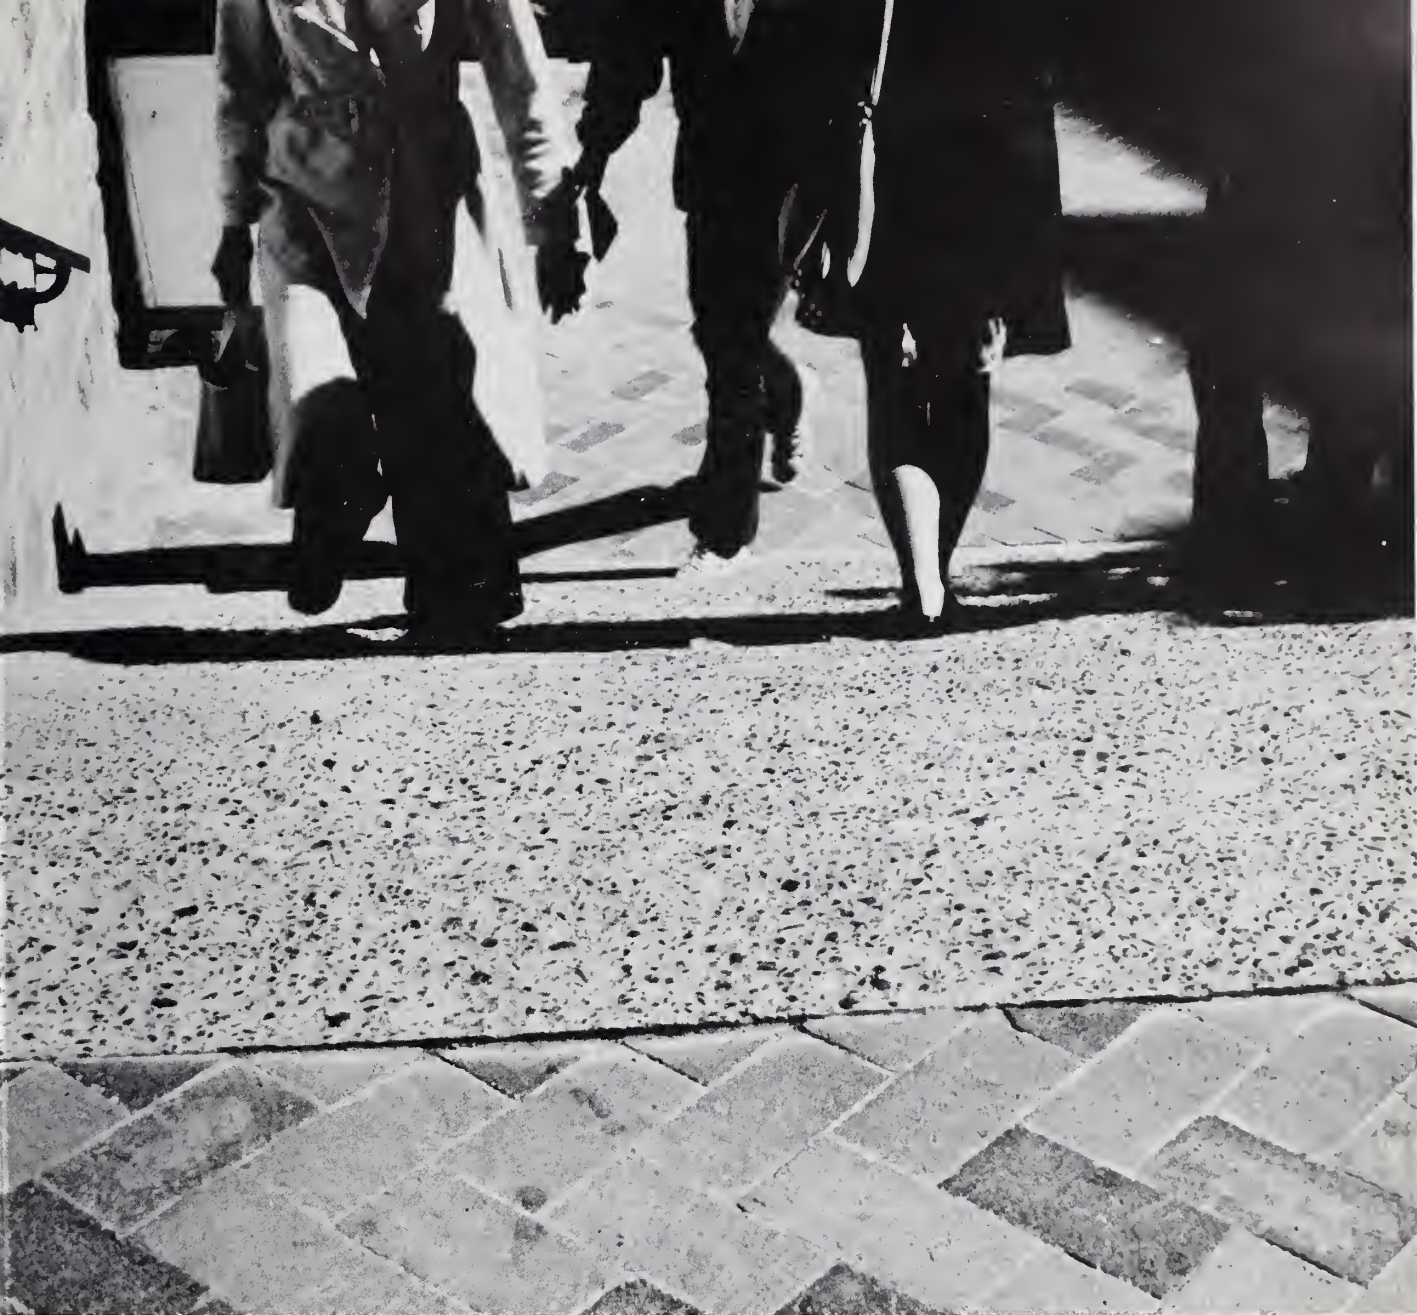
Facing page: The appearance and texture of stair surfaces frequently make it difficult to see the tread edges.

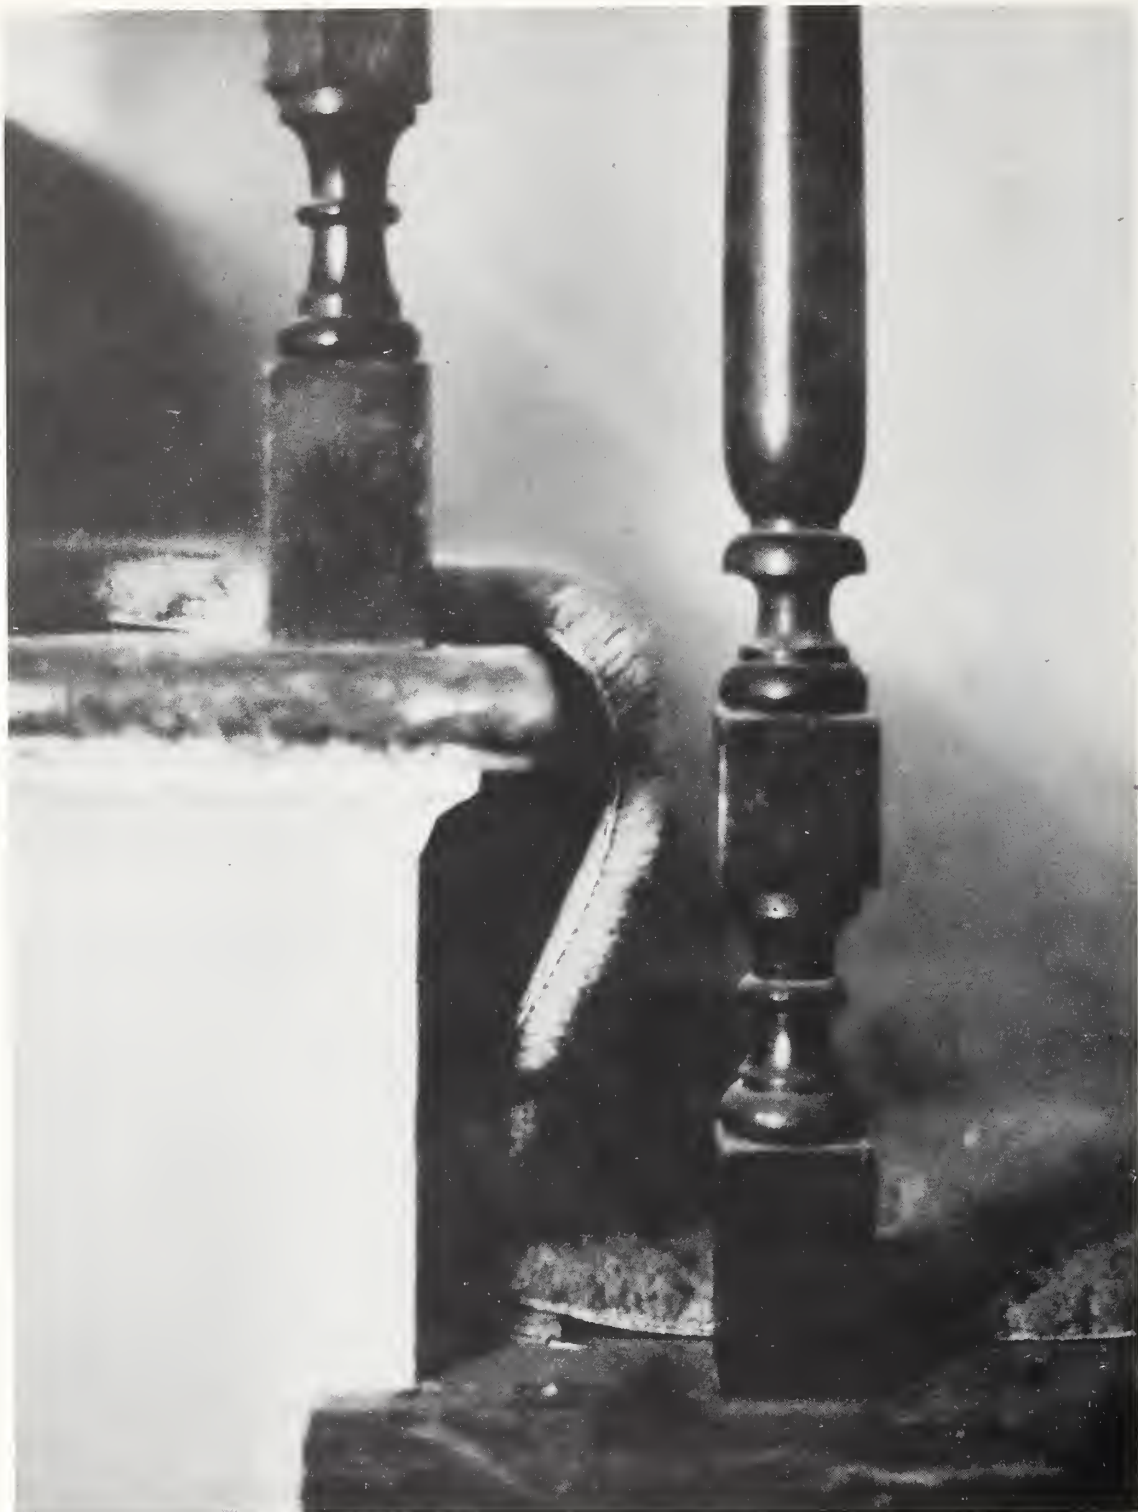
Figure 2.1.2

COMMENTARY - Whenever tread coverings or nosing strips separate from the tread itself, a tripping hazard is introduced. Tile, linoleum, rubber mats, carpeting, or metal strips can produce a 'lip' where they begin to peel or roll back from the tread. That lip can easily catch a user's heel or toe. Given the very small tolerances with which stair users clear the treads and nosings, even the most minor lip or edge created by loose coverings or strips can cause a major accident. This is particularly a problem at the beginning of a flight, because the user is primarily concerned with edge detection and can easily miss critical surface irregularities on the tread or nosing. It is also critical in the middle of a flight where the success of the user's initial performance on the stair generates a false sense of confidence leading to (1) even smaller tolerances for clearing nosings and (2) complete inattention to the stair treads themselves. In short, minor surface irregularities which can lead the user to trip and have a serious accident are among the most difficult characteristics of a stair to notice or anticipate. They should be eliminated wherever possible.

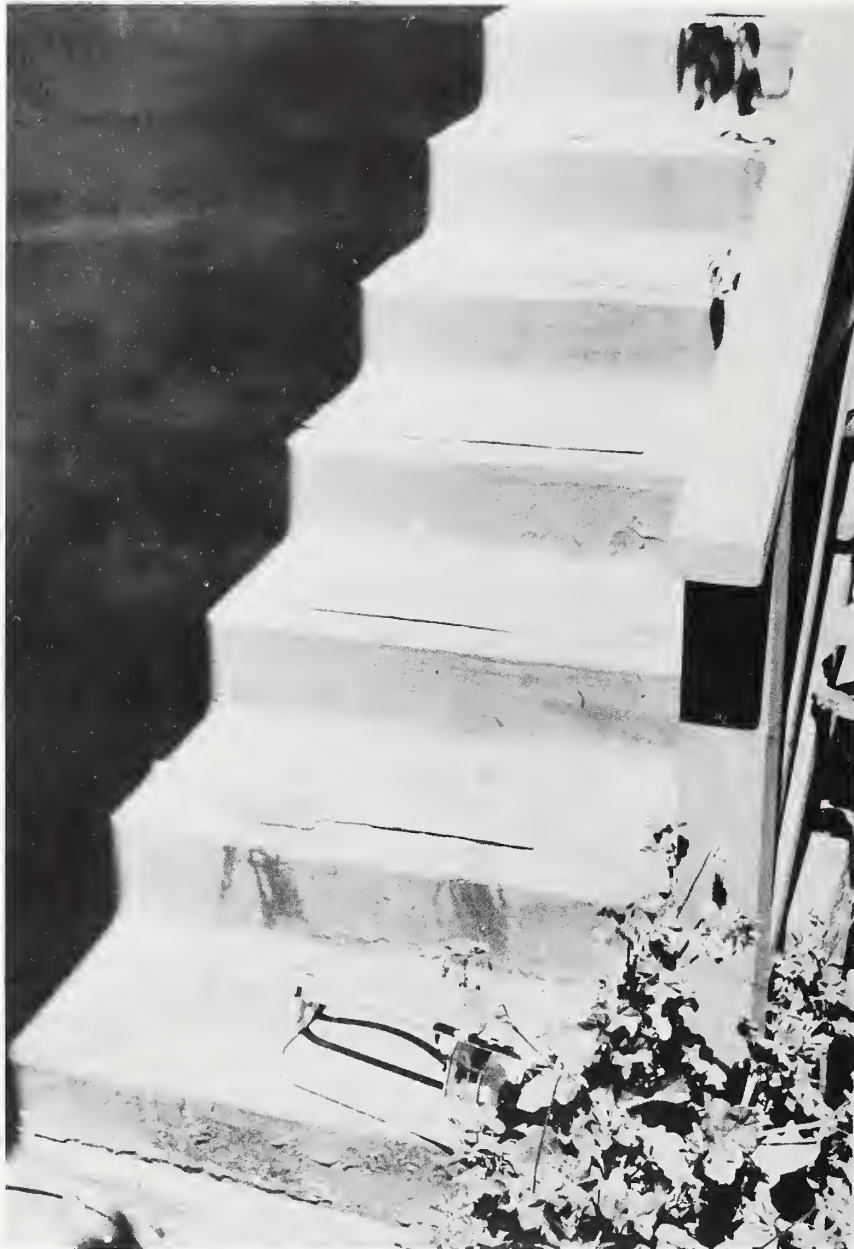
COMMENTARY - The distribution of body forces in walking up or down stairs creates less likelihood of slipping on stairs than on level floors. Yet sudden changes in slip-resistance from tread to tread or the insufficient surface resistance of worn, smooth treads can cause problems.

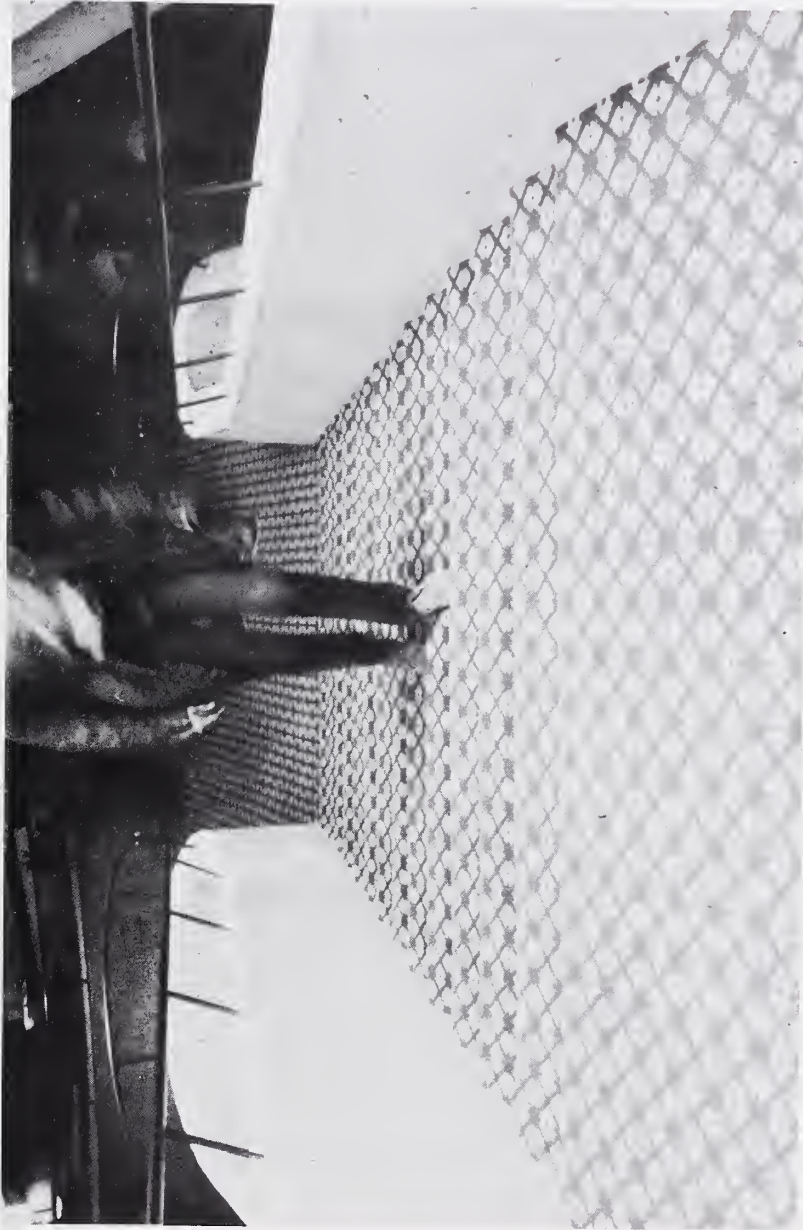
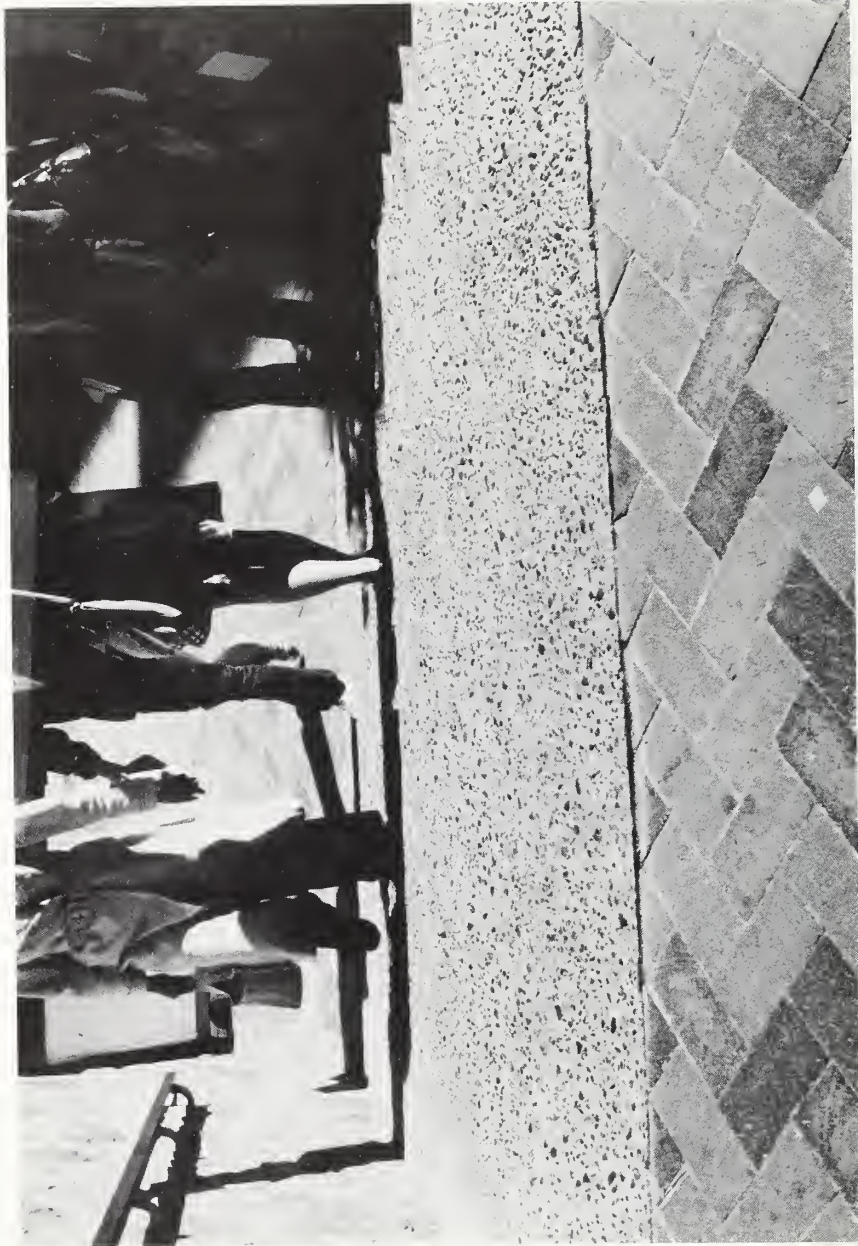
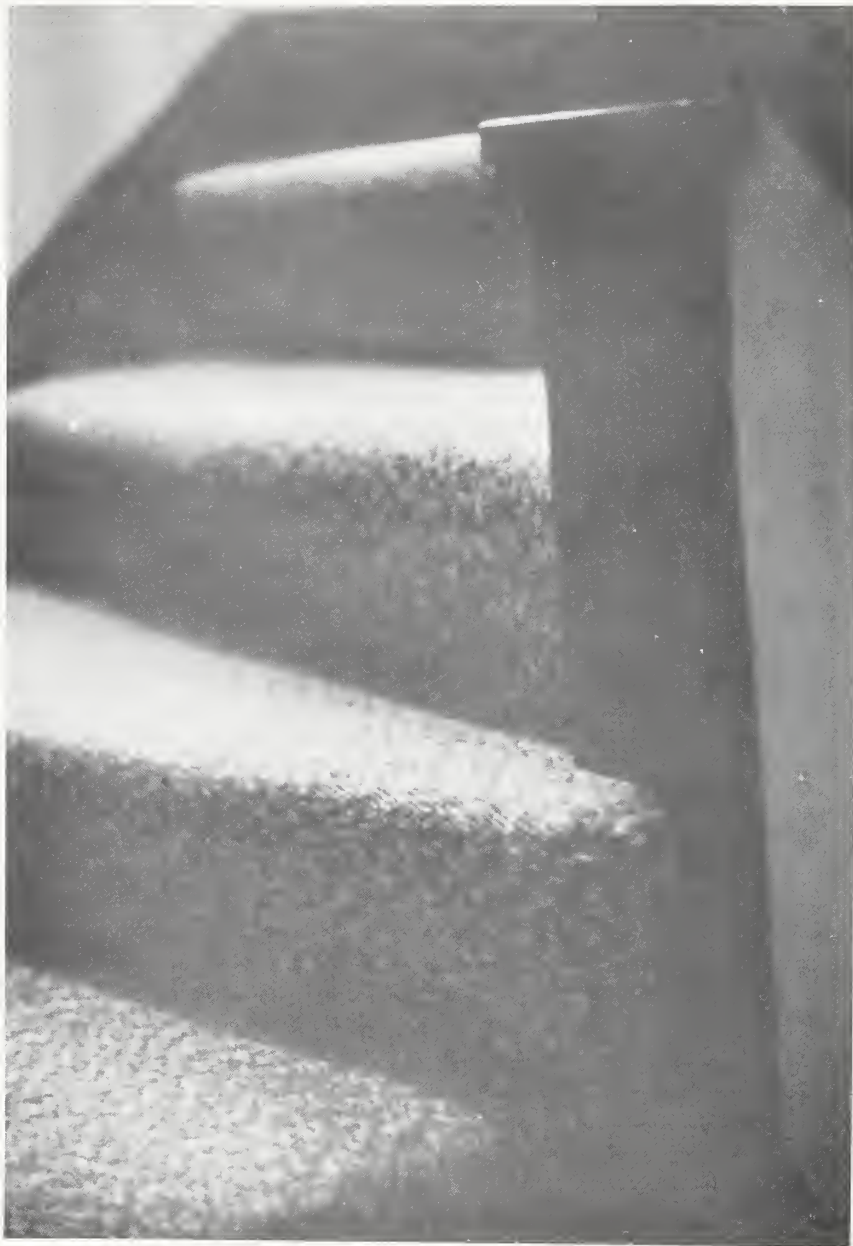
IF: the height or effective depth of any single riser or tread (except winders) varies by more than 1/4 in. across the width of the stair...

THEN: refinish the edge of every tread in the flight with a clearly visible strip of color, or illuminate the flight so that the

highlighted nosings will produce a visual pattern of edges which accentuates the location of each irregularity.

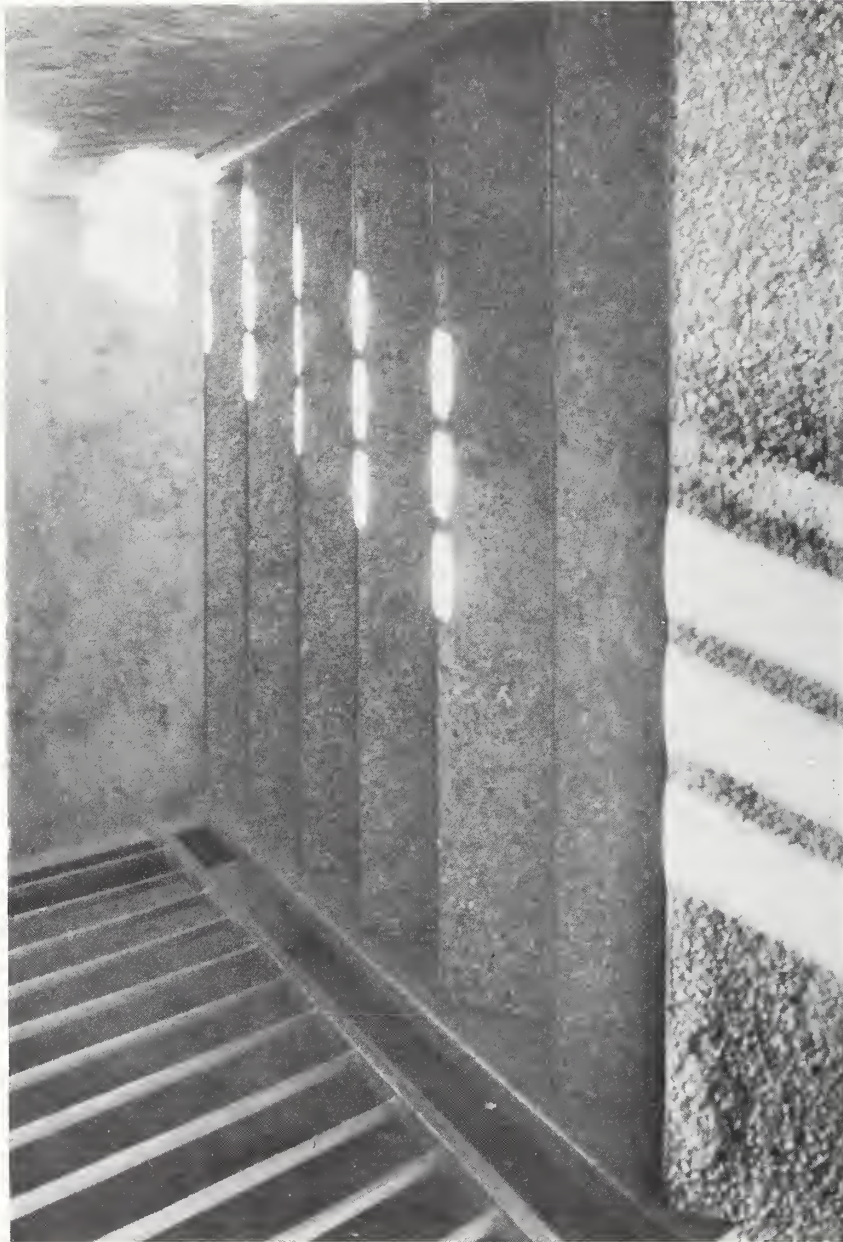
Figure 2.2.2

Figure 2.2.2. The second tread on this stair is more than one inch out of alignment with the other treads (note that the sunlight misses the second tread altogether). The third tread from the bottom is also slightly out of alignment (note a narrower band of sunlight than on adjacent treads).

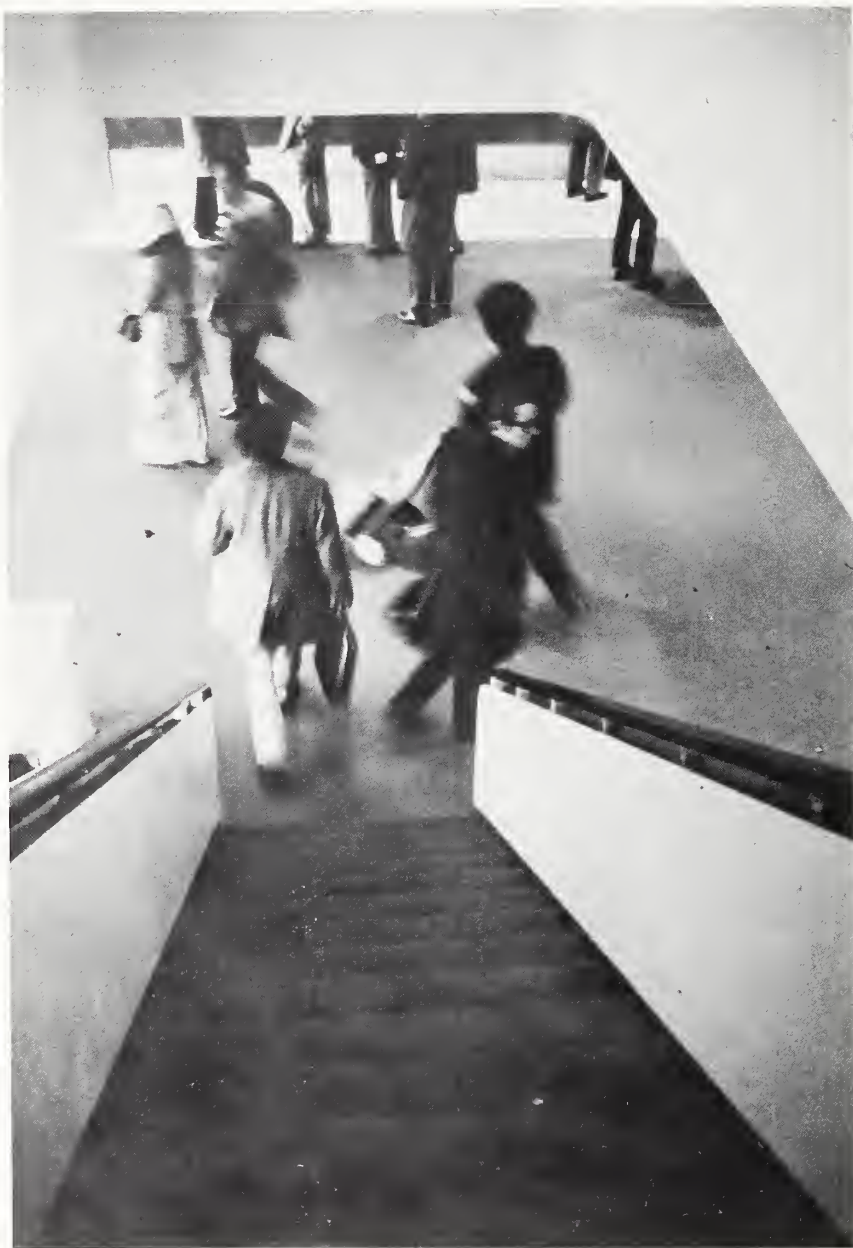
Figure 2.5.2a

Figure 2.5.2a. As users approach this stair from above, they must first descend into an enclosure which completely obscures their view of the scene below. At the top of the flight, the enclosure ends, creating a

view of the floor below. This scene is exposed to descending users at precisely the point where their attention should be directed toward the stair itself.

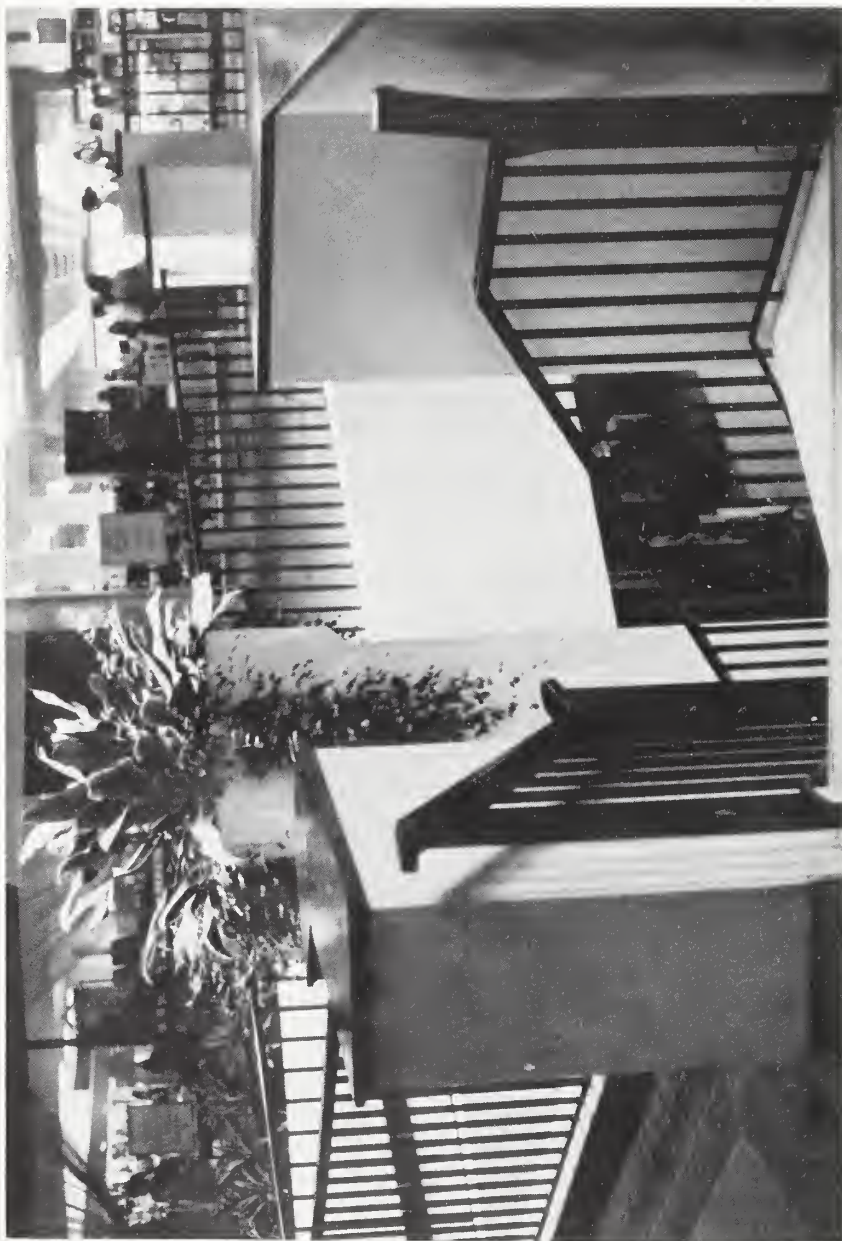
Figure 2.5.2b

COMMENTARY - The potential for being distracted by a view through an open riser is a variation of the "orientation edge" problem. Here again, the primary issue is whether the stair itself or something in the surrounding is a more compelling focus for the user's visual attention. The only additional hazard associated with views through open risers is related to the interference or flicker introduced by the stair treads which appear to move across the foreground while the user ascends the stairs. The resulting discontinuous view through the open risers may induce the user to neglect the stair itself, because he must concentrate on overcoming the repeated disruption created by each passing tread.

If the user stops to scrutinize the scene before resuming his ascent, he could block traffic and be a potential hazard on heavily traveled stairs.

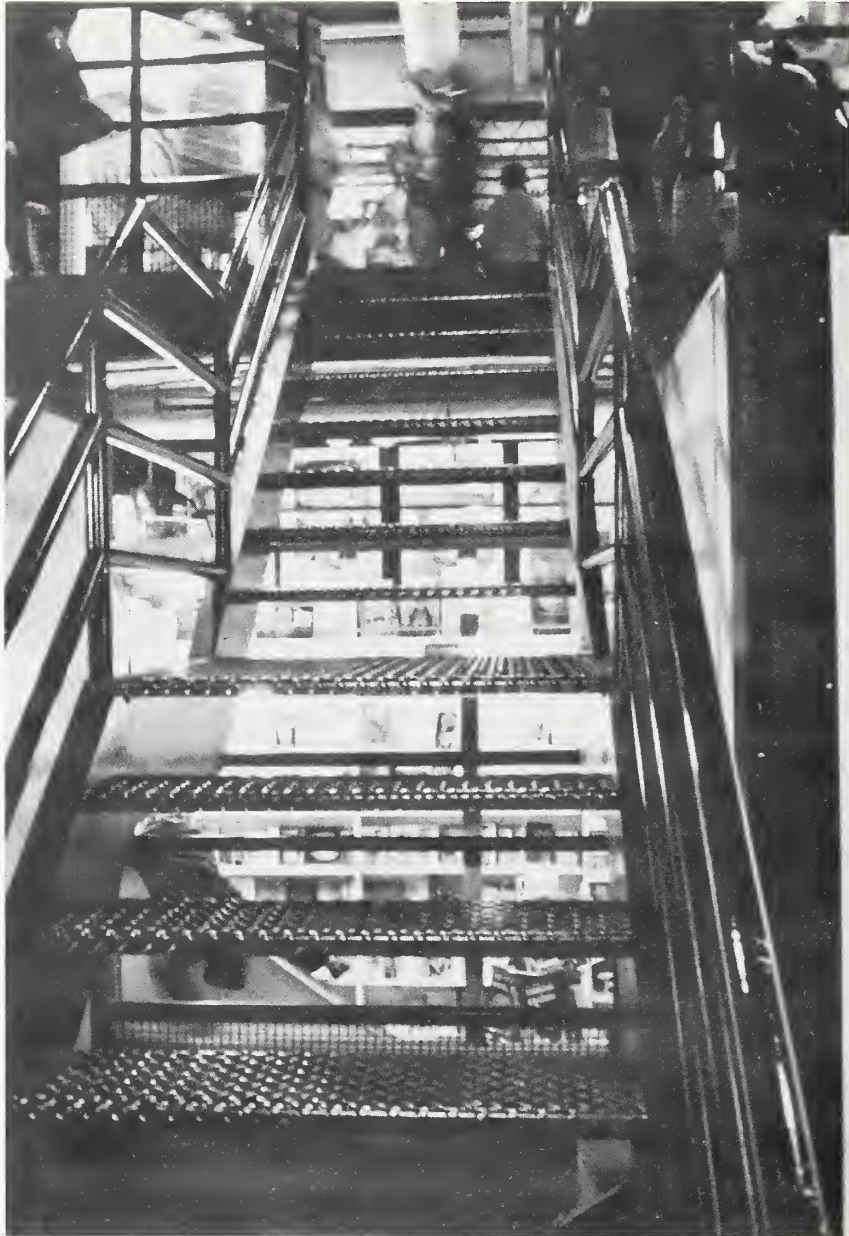
Figure 2.5.3

THEN: either (a) block the source of glare with translucent or opaque shades or screens, (b) reduce the reflectance of any surfaces which reflect bright lights or (c) move the offending bulb or fixture beyond the range of the user's functional visual field.

COMMENTARY - The total amount of light on the treads and handrails is one of the critical factors in the user's ability to detect prevailing stairway conditions. However, an adequate quantity of light does not ensure that the quality of illumination is particularly good on a given flight of stairs. If the angles of incidence and of reflectance combine with highly reflective surfaces to produce glare when the user looks at the treads, increases in light level could actually diminish his ability to acquire useful information. Finally, when the source of illumination falls within the user's visual field while looking at the stair, there is a distinct possibility that the intense brightness in one portion of the visual field may actually reduce the user's ability to acquire useful information from the remainder of the visual surroundings.

On many residential flights of stairs, the fixture which illuminates the stairway is clearly visible when the user is looking toward the stairs in descent. This condition may not only reduce a person's ability to discern details, but could also produce an afterimage which makes it difficult to process any visual information for several seconds afterward. Glare from overhead light sources, and the resulting afterimage, becomes even more critical for the elderly and visually handicapped (Pastalan, et al., 1973; Weale, 1963). During ascent, similar glare problems can arise from lights over an upper landing or from decorative lighting beneath stair treads.

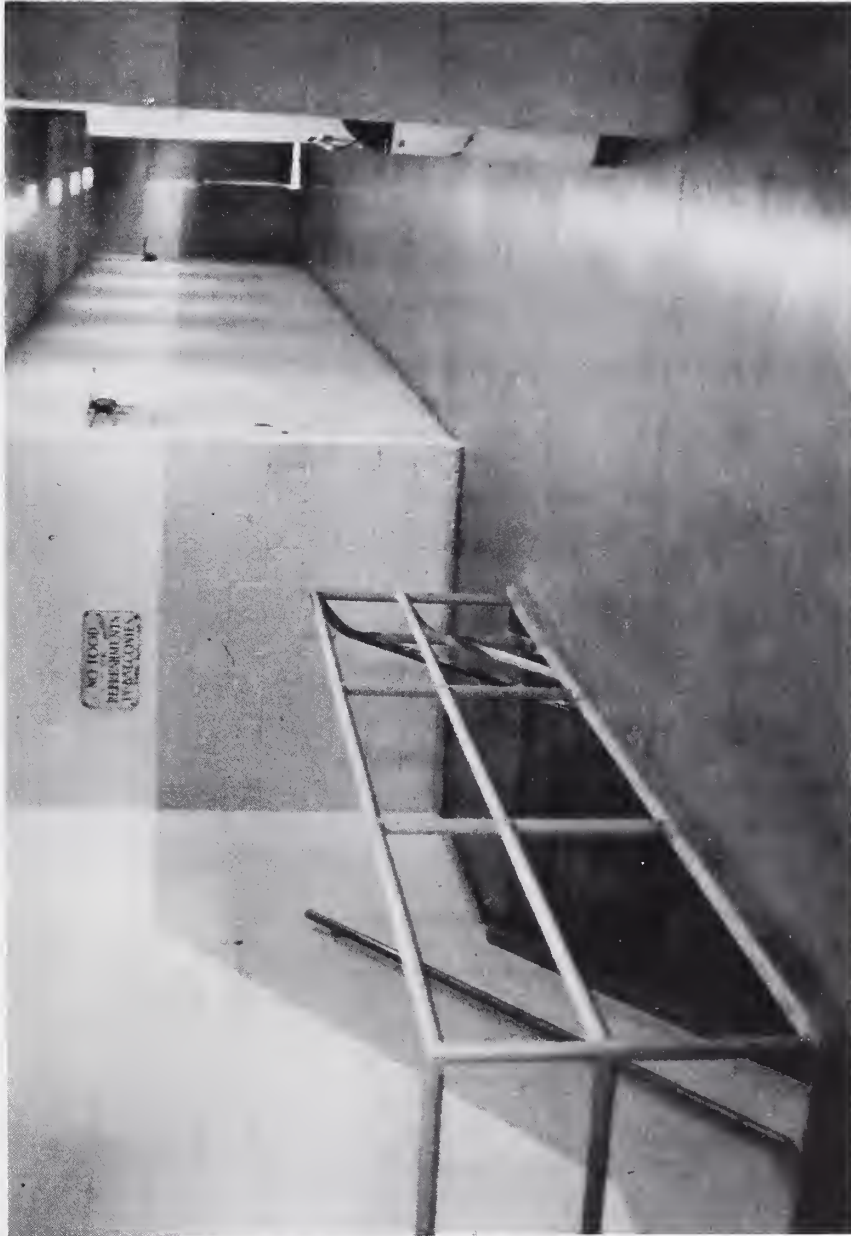
Figure 2.7.5

COMMENTARY - The analysis of the NBS videotapes indicated that detection of the first step was a critical component in the transition from level walking to stair movement (Templer, et al., 1978). This analysis further indicated that the detection process involves both a visual and a tactile-kinesthetic component. When the visual component is eliminated or reduced by some sort of handicap, then the tactile-kinesthetic component should be accentuated, through changes in texture on the floor, or the walls. Provision of changing auditory cues is also possible. It is important to ensure that these non-visual cues do not interfere with the non-handicapped person's use of the stairs.

Although the use of tactile cues on the floor or the wall has been recommended in some instances for the visual handicapped (Agate, 1966), there is no consensus about the most effective means of alerting users about

potential dangers or changes in elevation in their path. Nevertheless, the use of auditory or tactile cues appears to be a good means of alerting all users to change in their immediate path of travel.
